# MAXIM MAXREFDES79 4 port IO-Link Master V1.1.2 Test Report

Document ID	RP_ICBT_027_002
Author	LM/OW
Issue Date	29-01-2015
Reviewed	
Status	Draft
Version	11

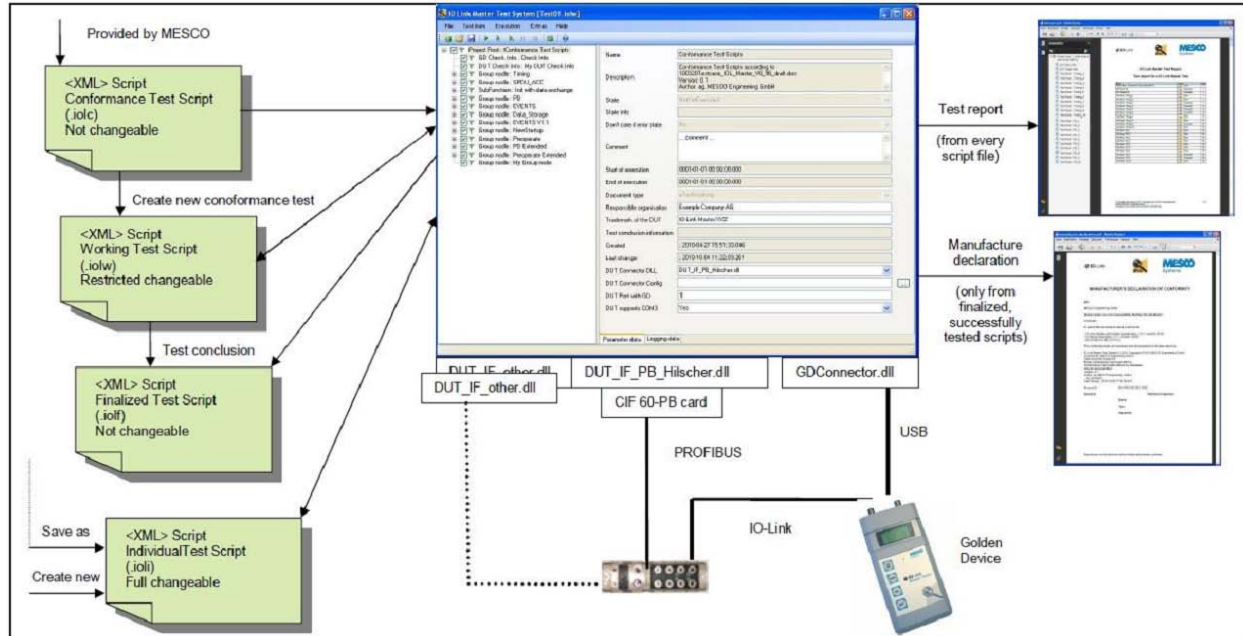
Figure 1 Test Environment with DUT: IO-Link Master MAXREFDES79

Figure 1 Test Environment with DUT: IO-Link Master MAXREFDES79 ..... 4
