## WHISKER TEST REPORT (FINAL REPORT)

Factory	Amkor Technology Philippines – ATP
Plating Finish	Matte Sn
Package Type	SOIC
Plating Chemistry	ST380
Plating Line	Meco 6
Post Plating Bake	150°C for 1 hour

Report Date : January 15, 2007  
Whisker Test Report # : 20060623

1.1. Whisker Test on SOIC 8lds (C194 Base Metal) ST380 Chemistry.

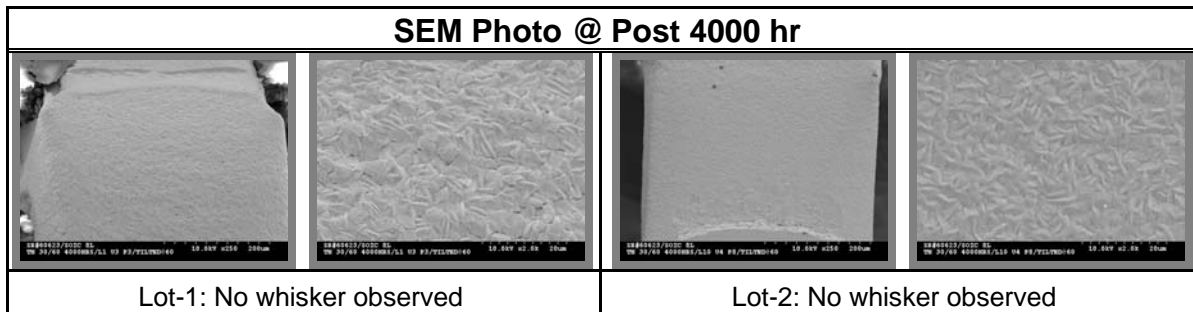
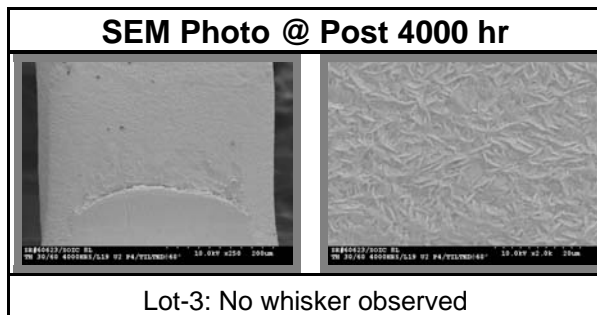
Lot No.	Component # / Termination #	Readpoints				
		0 hr	1000 hr	2000 hr	3101 hr	4000 hr
Lot-1	Comp # <u>3</u> / Term # <u>3</u>	none	none	none	none	none
Lot-2	Comp # <u>4</u> / Term # <u>8</u>	none	none	none	none	none
Lot-3	Comp # <u>2</u> / Term # <u>4</u>	none	none	none	none	none

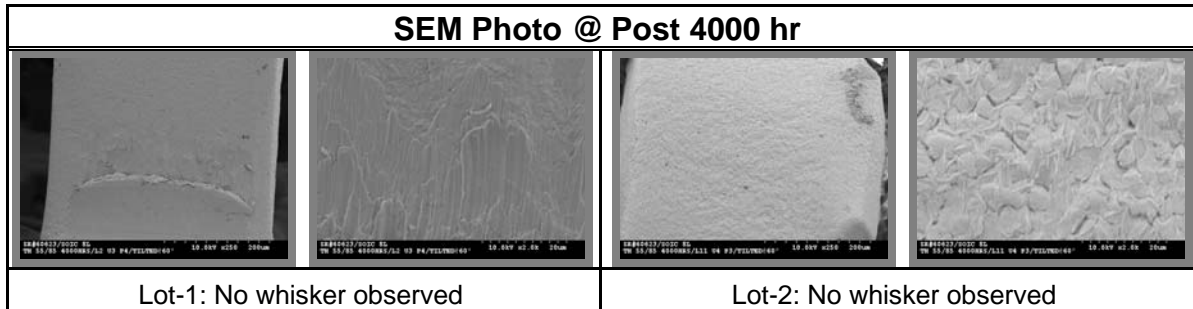
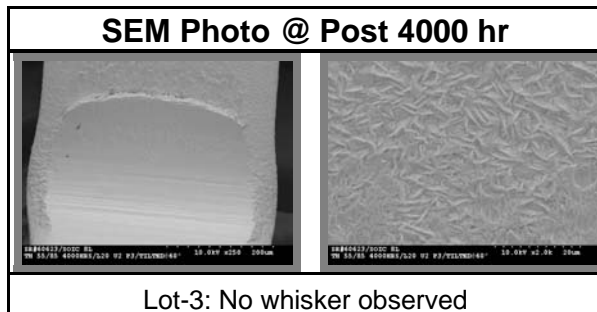
#### SEM Photo @ Post 4000 hr

Lot No.	Component # / Termination #	Readpoints				
		0 hr	1000 hr	2000 hr	3161 hr	4000 hr
Lot-1	Comp # <u>3</u> / Term # <u>4</u>	none	none	none	none	none
Lot-2	Comp # <u>4</u> / Term # <u>3</u>	none	none	none	none	none
Lot-3	Comp # <u>2</u> / Term # <u>3</u>	none	none	none	none	none

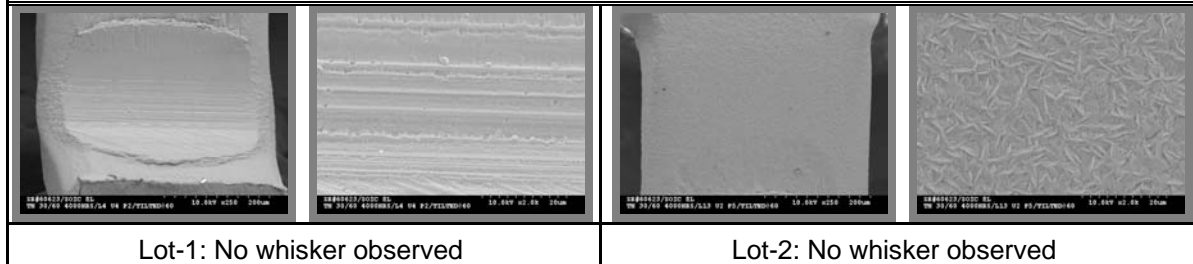
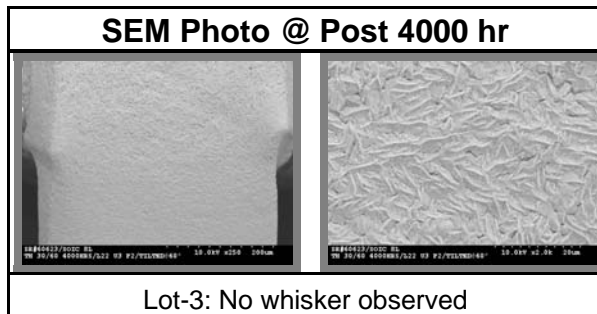
#### SEM Photo @ Post 4000 hr

Lot No.	Component # / Termination #	Readpoints				
		0 hr	1000 hr	2000 hr	3101 hr	4000 hr
Lot-1	Comp # <u>4</u> / Term # <u>2</u>	none	none	none	none	none
Lot-2	Comp # <u>2</u> / Term # <u>5</u>	none	none	none	none	none
Lot-3	Comp # <u>3</u> / Term # <u>2</u>	none	none	none	none	none

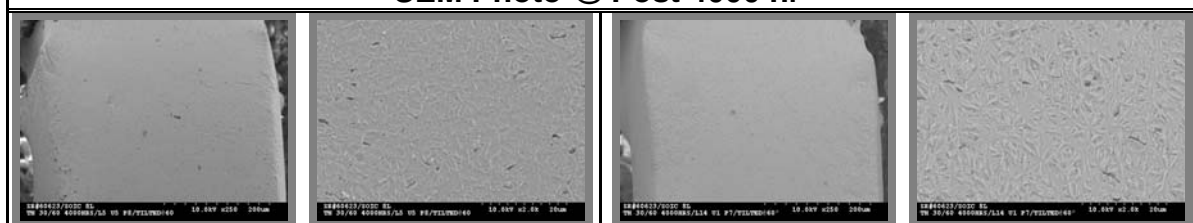
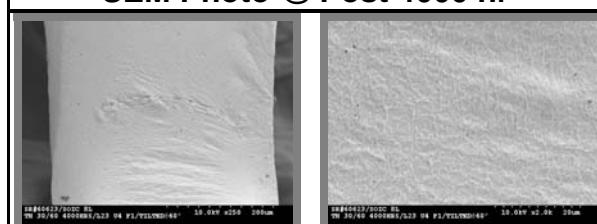
**SEM Photo @ Post 4000 hr**

Lot-1: No whisker observed	Lot-2: No whisker observed
----------------------------	----------------------------

Lot-3: No whisker observed

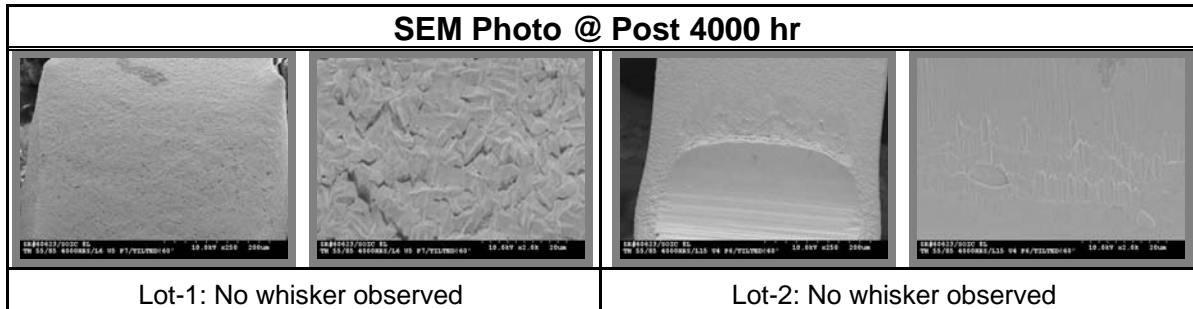
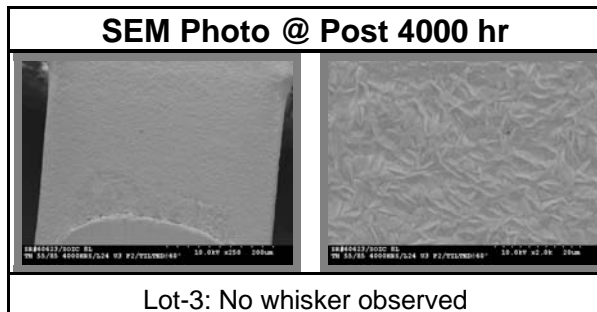
#### SEM Photo @ Post 4000 hr

Lot No.	Component # / Termination #	Readpoints				
		0 hr	1000 hr	2000 hr	3161 hr	4000 hr
Lot-1	Comp # <u>5</u> / Term # <u>7</u>	none	none	none	none	none
Lot-2	Comp # <u>4</u> / Term # <u>6</u>	none	none	none	none	none
Lot-3	Comp # <u>3</u> / Term # <u>2</u>	none	none	none	none	none

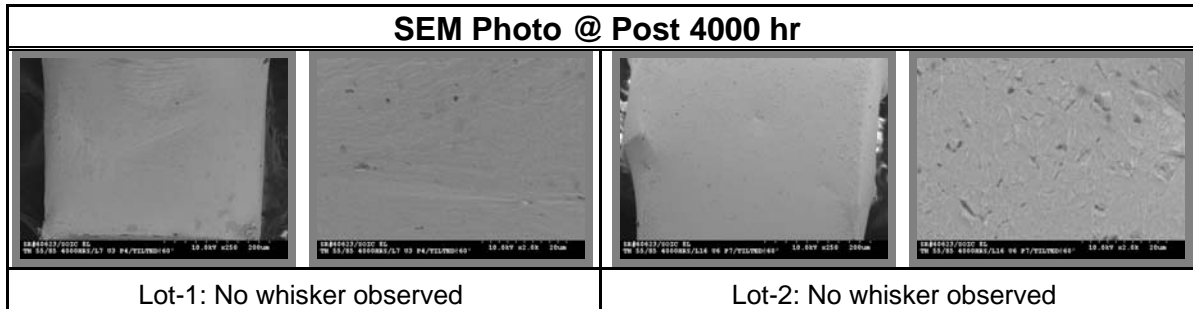
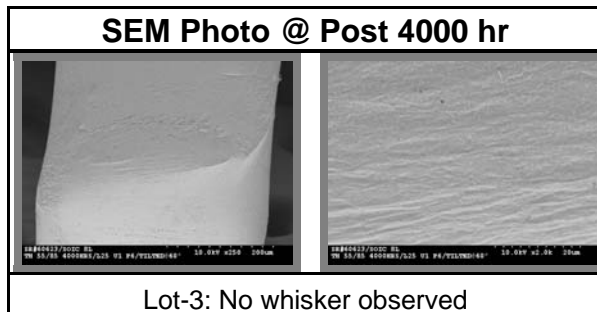
#### SEM Photo @ Post 4000 hr

Lot No.	Component # / Termination #	Readpoints				
		0 hr	1000 hr	2000 hr	3161 hr	4000 hr
Lot-1	Comp # <u>3</u> / Term # <u>4</u>	none	none	none	none	none
Lot-2	Comp # <u>6</u> / Term # <u>7</u>	none	none	none	none	none
Lot-3	Comp # <u>1</u> / Term # <u>6</u>	none	none	none	none	none

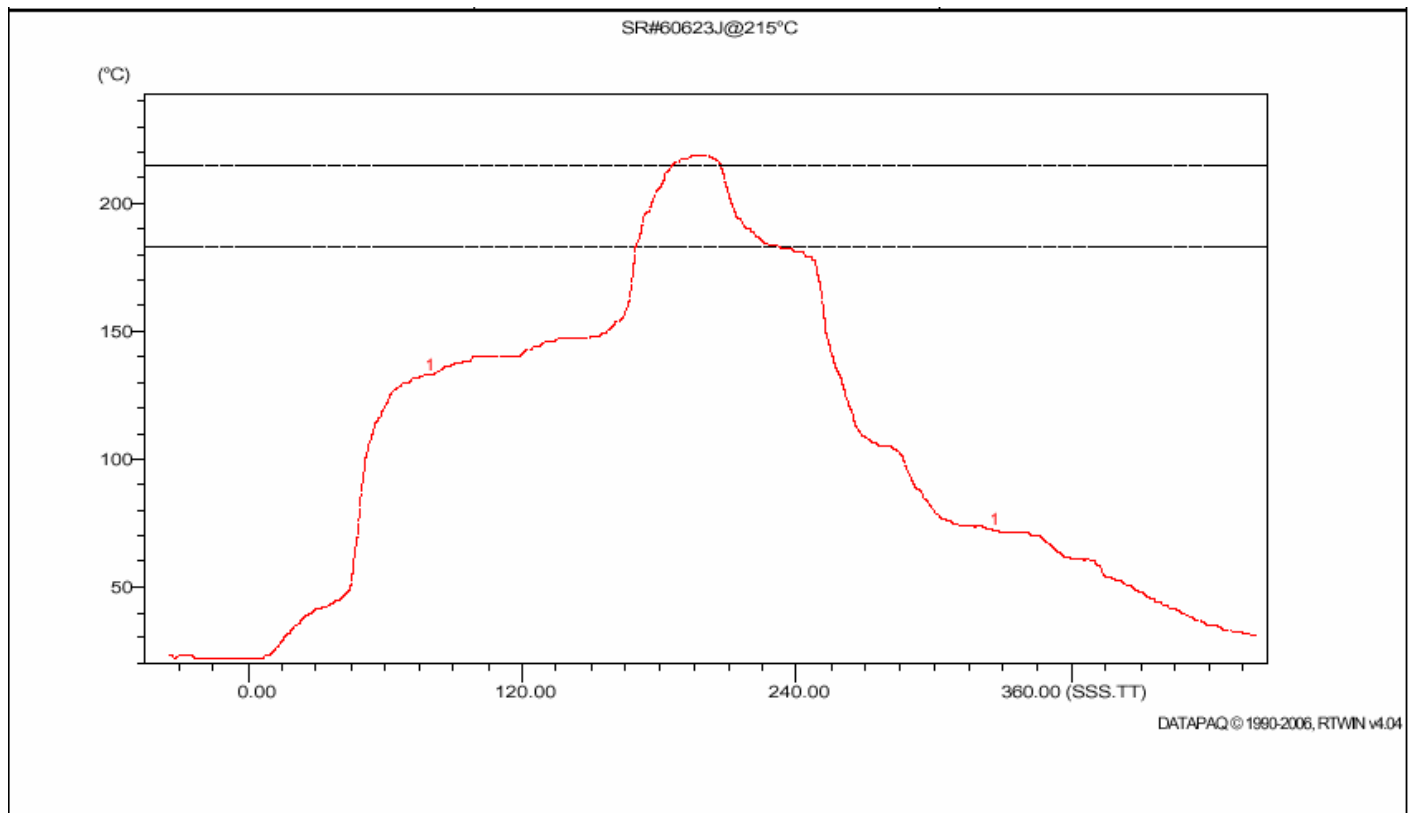
#### 5.4.2.1. Simulated 215°C Reflow

Post Plating Bake	Yamato	Hold Temperature	150°C		
		Dwell Time	1 hr		
		Total Cycle Time	1.5 hr		
Simulated Reflow @ 215°C	Vitronics	Peak Temperature	219°C		
		Dwell Time > 183°C	63 seconds		
Simulated Reflow @ 255°C	Vitronics	Peak Temperature	259°C		
		Dwell Time > 217°C	74 seconds

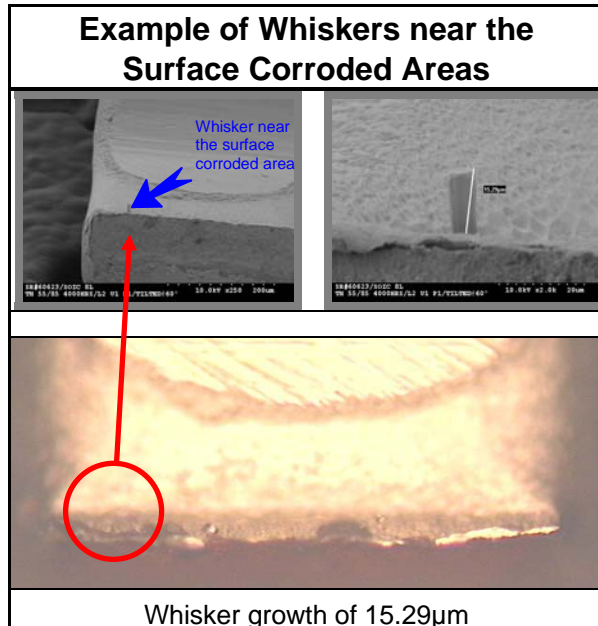
#### 5.4.3.2.1. High Temperature/Humidity (55°C/85%RH)

3.2.4. Two (2) terminations with whisker, which were found at the lead tip, have been invalidated after exposure to higher Temperature/Humidity (55°C/85%RH) conditions due to presence of surface corrosion. The invalidation was done per JEDEC Standard JESD201. Other terminations were inspected but no whisker was found. Verification results were detailed at the end of report under Appendix 5.4.3.

Surface Corrosion: A localized change to a silver-colored Sn surface finish appearing in an optical microscope as non-reflective dark spots ranging in size from about 25 micrometers on the longest dimension to the entire termination.
